S5000 TECHNICAL BULLETIN

Date	13/10/2021
Topic	Upright Water Ingress
Priority	High - Mandatory

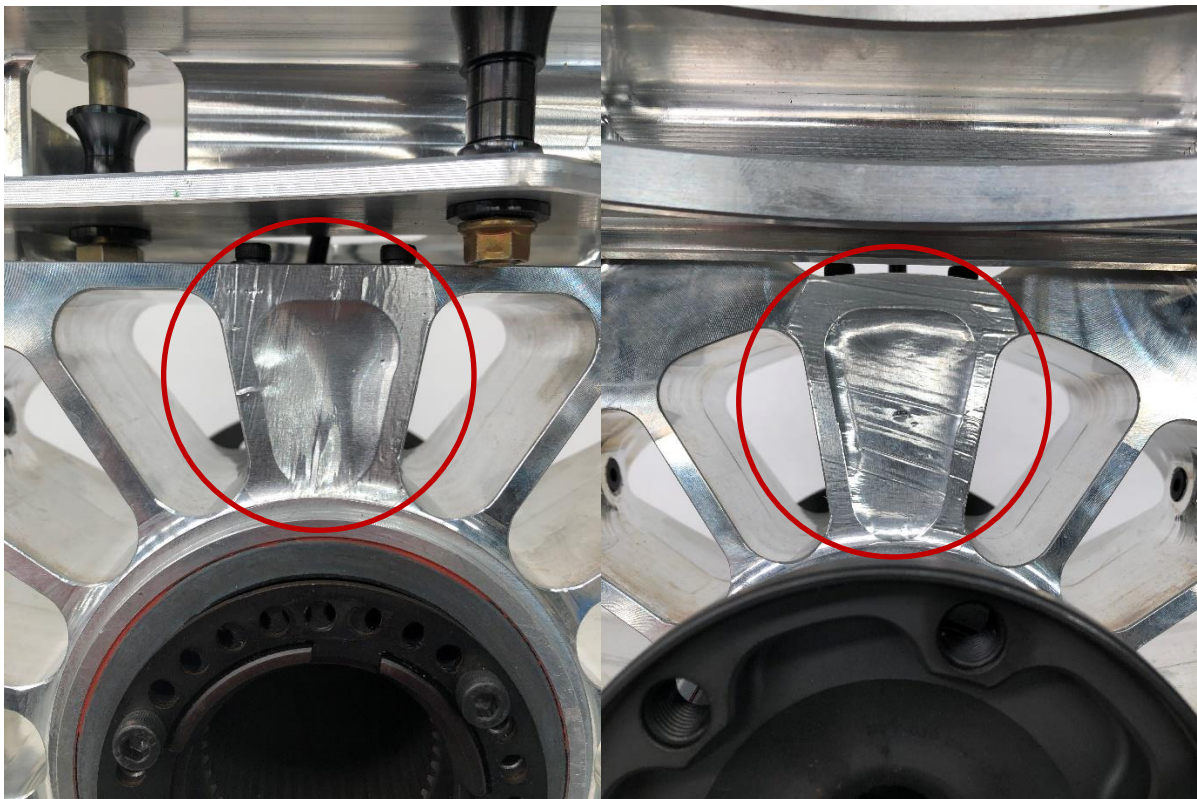
After the wet weather races this year, some uprights were found to have seized bearings.

It occurred several days after the race meeting and after disassembly rust was found in the bearings.

A vast majority were rear uprights, however there also was an instance of rust in the front upright bearings.

The upright breathes through the wheel speed sensor opening as it heats up and cools down. The design of the rear upright brake duct especially means in wet weather, most of the water will be directed through the speed sensor web opening in the upright housing.

Proposed solution is to cover the wheel speed sensor opening with aluminium tape as shown below. This modification should be done straight away and has been completed on all uprights serviced after SMSP.
