S5000 TECHNICAL BULLETIN

Date	18/05/22
Topic	Water Header Tank Fatigue
Priority	Maintenance

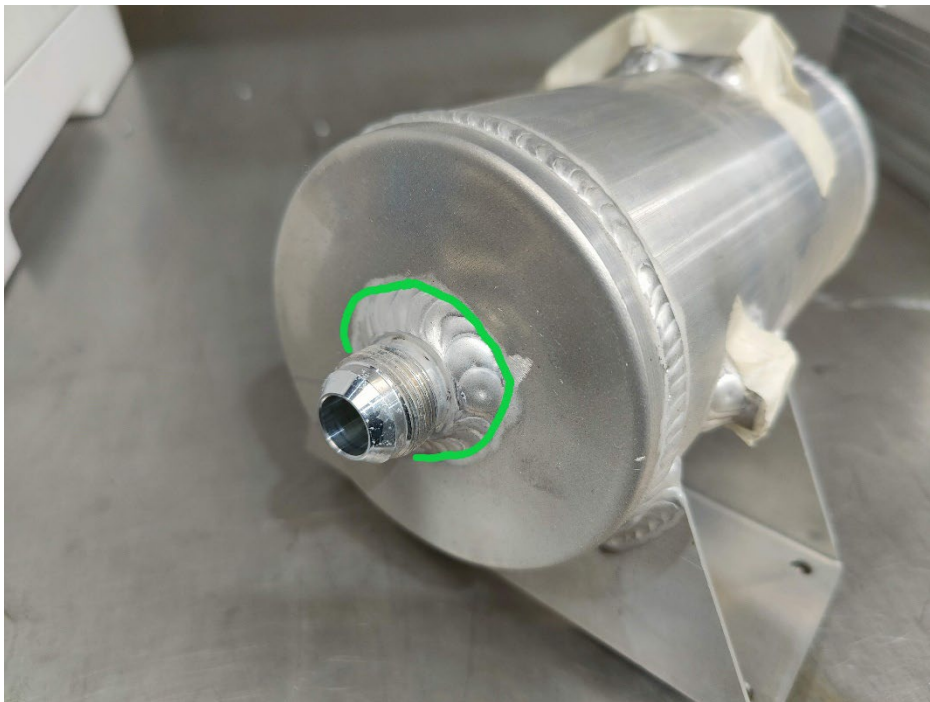
We have seen several instances where the weld on the bottom fitting of the water header tank has a fatigue crack and started to leak.

Please keep an eye on this area and weld any cracks if required.

GRM is currently doing a design revision of the header tank to address this issue which will be rolled out when ready.
