## S5000 TECHNICAL BULLETIN

Date	18/10/2022
Topic	Push Rod & Steering Adjusters
Priority	Mandatory

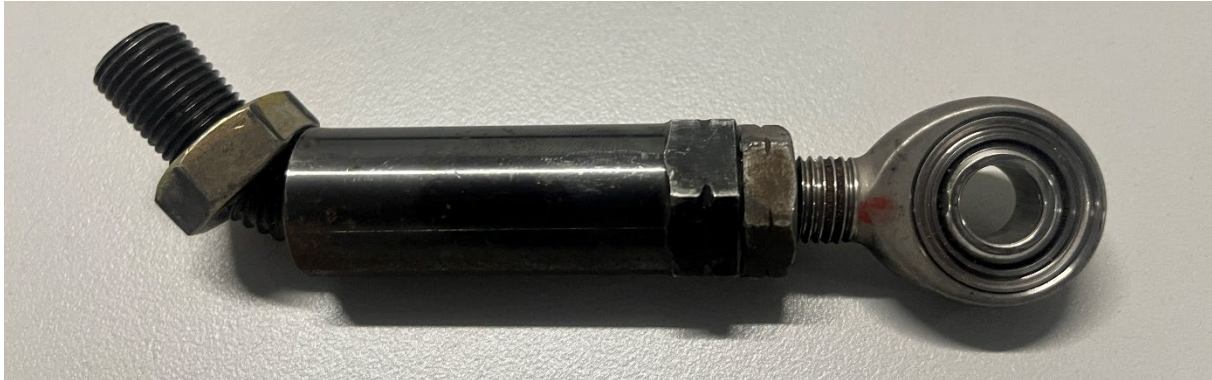
Failures of the front, rear and steering adjusters have been occurring when the vehicle is subjected to large jolts, typically seen when the driver dips a wheel off the edge of the circuit.

The current failure mode with the significant bending of the adjusters is not ideal as a large variation in push rod and steering arm length occurs as a result.

This is not ideal as the vehicle typically becomes uncontrollable due to large variations in corner weight.

The material specifications have been altered to increase the load capacity of the adjuster's, latest specification adjusters now have the following part numbers and are mandatory:

Steering Arm Adjuster – GRM-AF0452-02

Front Push Rod Adjuster – GRM-AF0451-03

Rear Push Rod Adjuster – GRM-AG0475-03

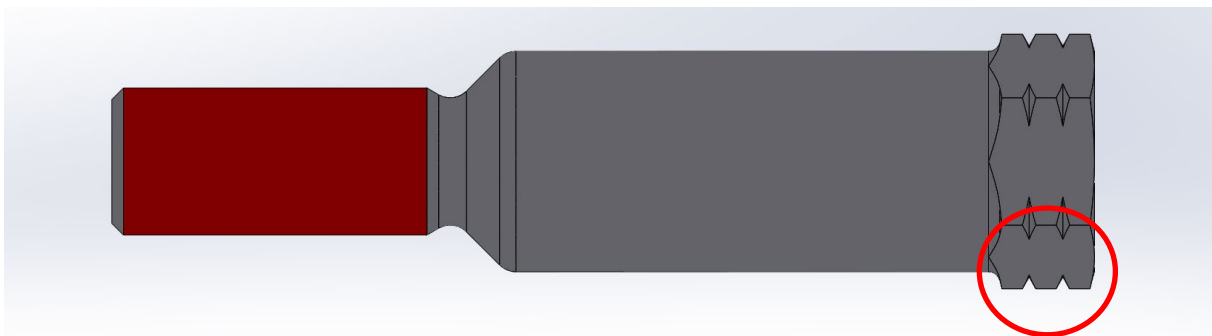
Latest specification adjusters can be identified by the presence of 2 notches grooved into the hex as seen below:
