## S5000 TECHNICAL BULLETIN

Date	6/02/23
Topic	Secondary Exhaust Attachment
Priority	Recommended Optional

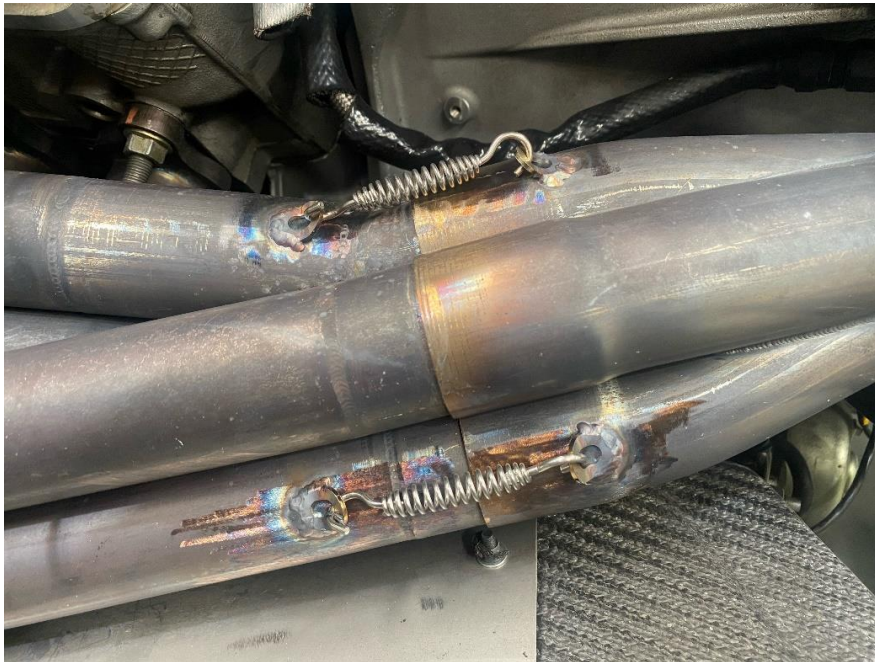
The current method of attachment between the primary and secondary exhaust sections displays potential for failure in multiple ways:

- Through vibration, the k-nuts specified for use on the fixings either loose tension or the nut fails altogether
- Cracking of the welds that secure the tabs to the pipes

This can result in the secondary pipes being disconnected from the primary pipes, causing a loss in performance, risk of Mechanical Black Flags and extreme engine noise levels.

We have revised the method of attachment of the two pipe sections to remove the current failure modes. The current specification of fixings should be totally removed.

The new attachment features 2 tension springs per side (4 per car). A new tab design is to be used with one tab welded to the end of the primary pipe and one to the start of the secondary pipe.

The tabs should be welded in a position so that there is no twist in the spring once attached and so there is significant tension on the spring when the secondary pipe has been pushed all the way home.
