S5000 TECHNICAL BULLETIN

Date	17/03/21
Topic	GPS Location
Priority	Low

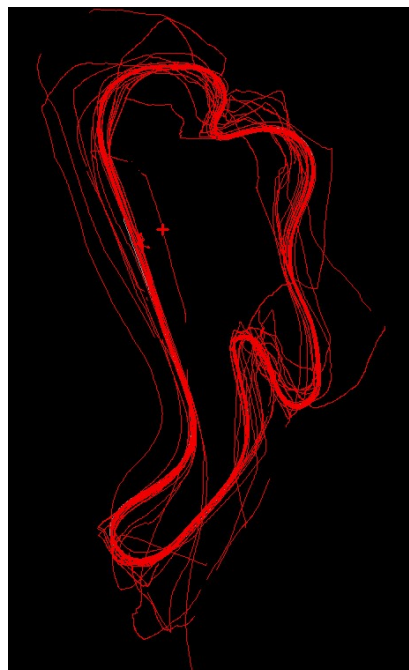
The GPS signal has been poor on most cars intermittently. The GPS controls the lap timing on the dash and logged data. It causes laps to be missed or incorrect short laps to be triggered.

The GPS track map sometimes looks like this:

The issue is coming from the mounting location and the fact that it is on a plastic base. A new location for the GPS at the base of the halo was trialled at Baskerville and then confirmed at Phillip Island.

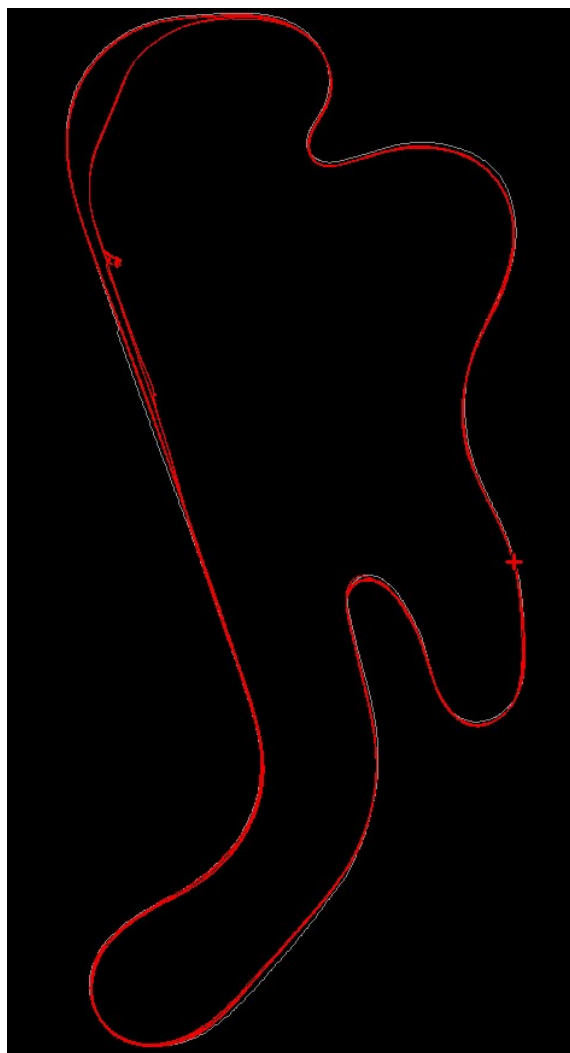
8. GPS Track Map should look like this:
