S5000 TECHNICAL BULLETIN

Date	11/10/2021
Topic	Sump Plug Access Hole
Priority	Low - Optional

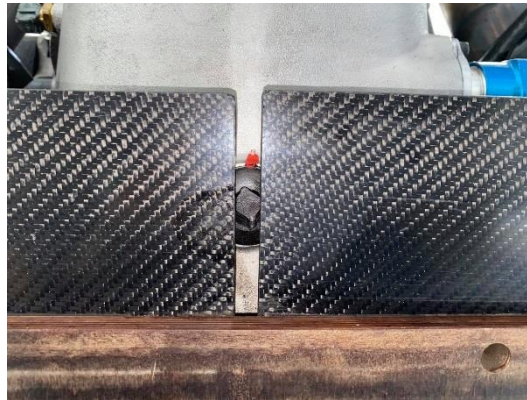
When the sump plug of the gear box needs to be removed for engine oil drainage, the carbon fibre rear floor undertray blocks the drainage point (See Figure 1).

FIGURE 1. BLOCKED DRAINAGE ACCESS POINT

A hole no larger than 50mm diameter will be allowed to be cut out of the undertray to allow access to the sump plug. Simply mark out the circumference of a cylindrical object onto the undertray (Figure 2) and slowly remove the carbon fibre (circular pencil grinder was used in Figure 3).

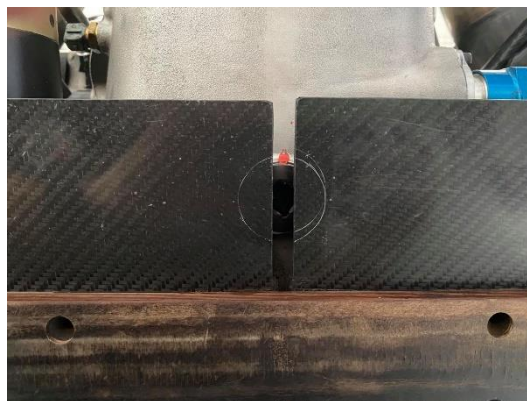
FIGURE 2. MARKED CIRCUMFERENCE

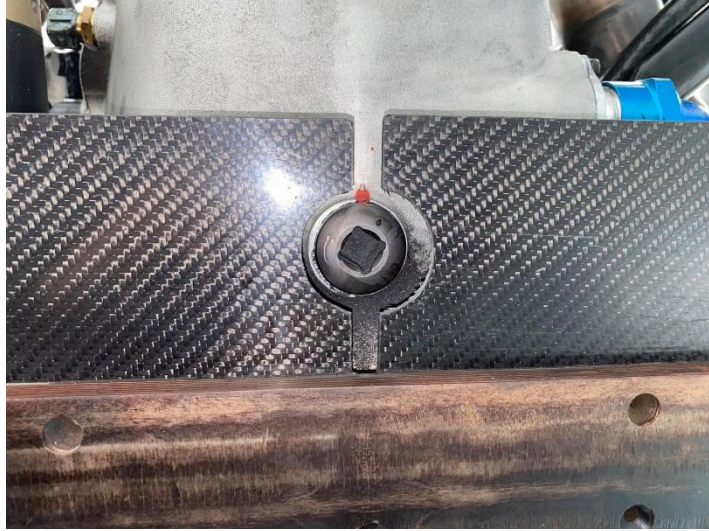
FIGURE 3. SUMP PLUG ACCESS HOLE
