## S5000 TECHNICAL BULLETIN

Date	18/05/22
Topic	Steering Rack Clamp Bolt
Priority	High

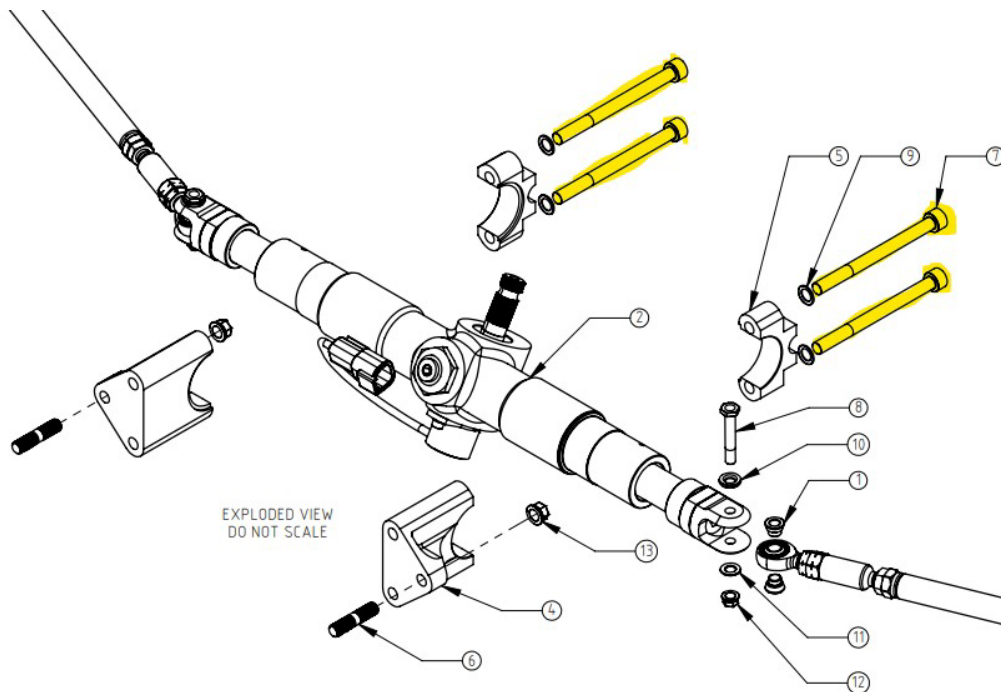
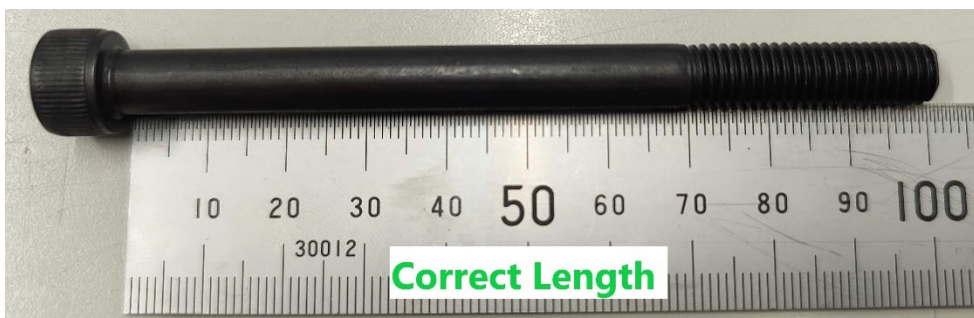
At the AGP in R3 we had a steering rack mount bolt strip the thread in the chassis bulkhead insert causing the rack to come loose and the car to DNF the race.

Upon inspection it was found that the 4x bolts (item 7, highlighted yellow below) were M8 SHCS 90mm Long with insufficient thread engagement.

Ensure M8 SHCS 100mm Long bolts are used in this application. Check all cars and replace if needed.
